USAF ACCIDENT/INCIDENT REPORT

1. DATE OF OCCURRENCE (Year, month and day) 1964 December 5, Saturday	2. VEHICLE(S)/MATERIEL INVOLVED (TMS & Serial No., if applicable) IGM-303 64-006	3. FOR GROUND ACCIDENTS ONLY (Base Code and Report Serial No.) 64-12-5-401 N/A
---	--	---

4. PLACE OF OCCURRENCE: STATE, COUNTY, DISTANCE AND DIRECTION FROM NEAREST TOWN. IF ON BASE, IDENTIFY. IF OFF BASE GIVE DISTANCE FROM NEAREST BASE. South Dakota, Butte County, Launch Facility Lima Two 28 NM NW Ellsworth AFB 78 019 GM31-N	5. HOUR AND TIME ZONE LOCAL 1500 MST	<input checked="" type="checkbox"/> DAY <input type="checkbox"/> NIGHT <input type="checkbox"/> DAWN <input type="checkbox"/> DUSK
---	---	---

NARRATIVE SEQUENCE OF EVENTS

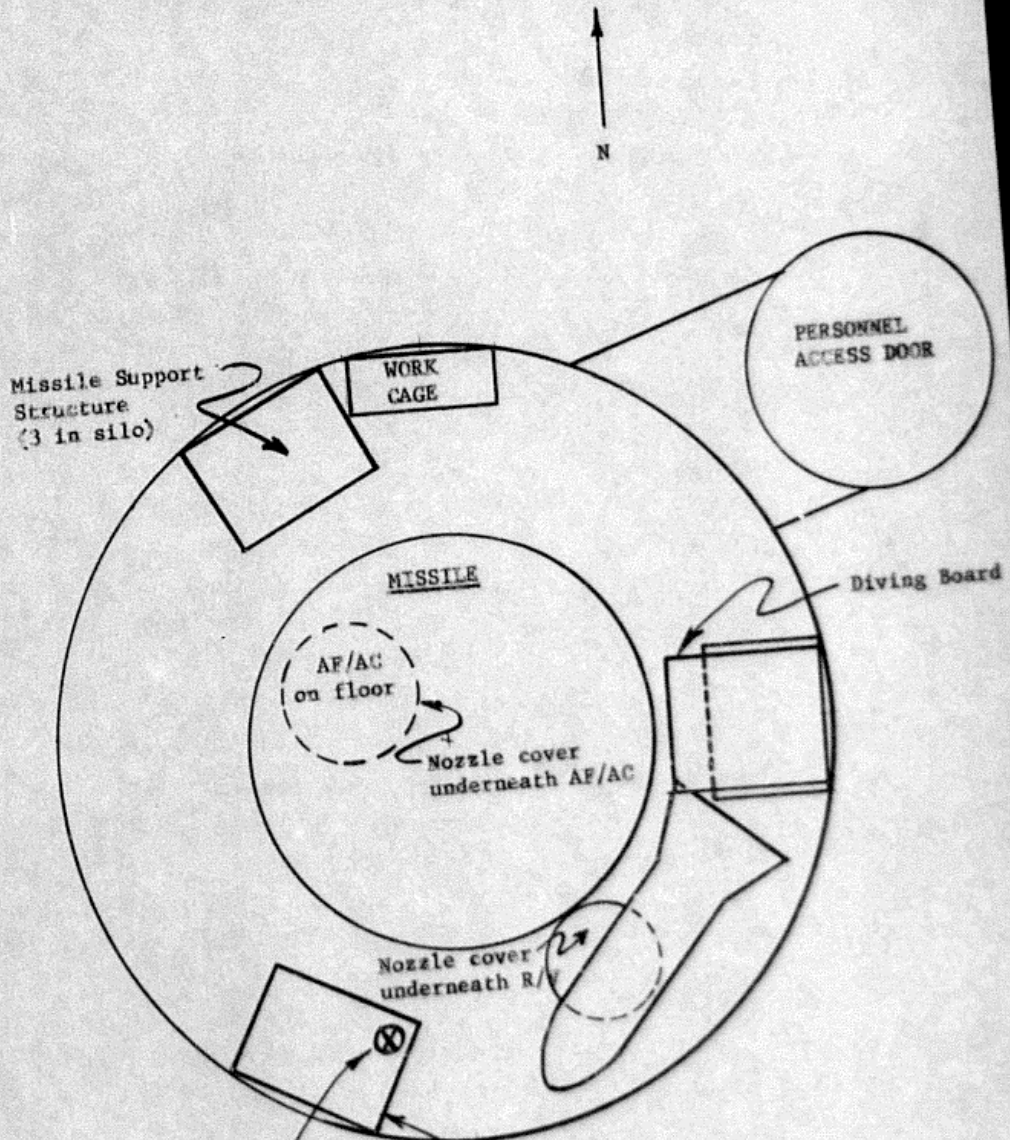
SILO FLOOR LOCATION OF R/V DEBRIS

It was subsequently discovered that the explosion, a re-entry vehicle retro rocket firing, had caused the re-entry vehicle to separate at the ball lock interface of the spacer assembly and topple approximately seventy-five feet to the floor of the launch tube.

R/V impacted on top of missile support structure. R/V windshield remained here.

Two feet above this missile support structure the silo plumbing was slightly bent by the falling R/V.

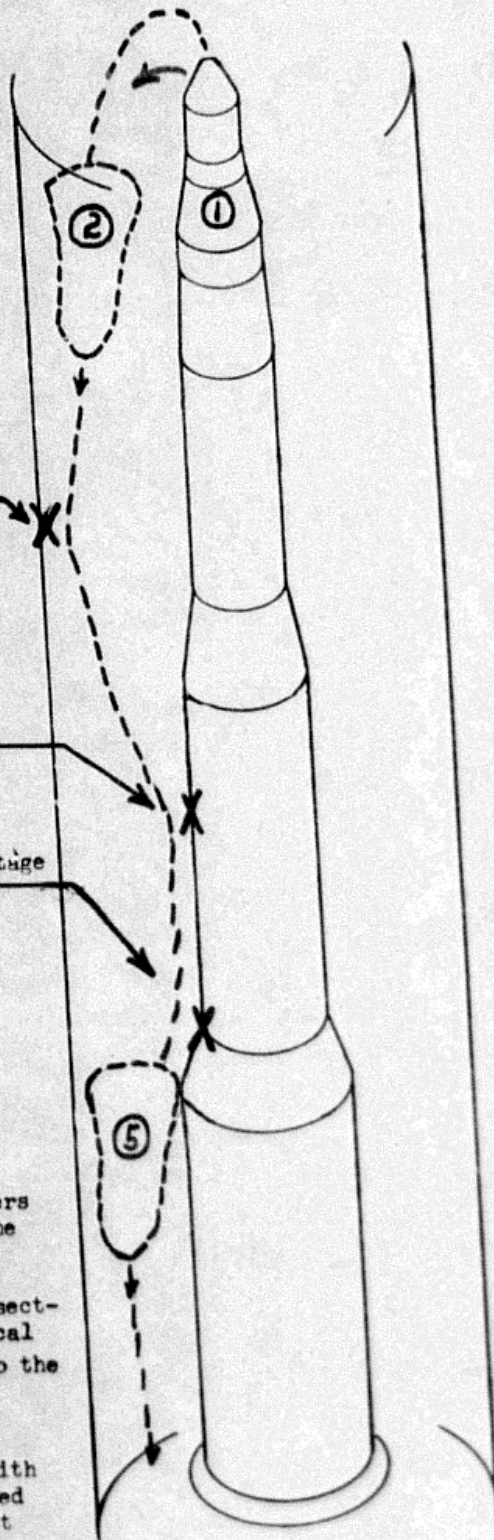
FALLING PATH OF RV

7. R/V rebounds and flare section hits 2nd of three vertical support members and slams to the floor flare first.

8. R/V rests in horizontal position against the wall with the aft end of the R/V butted against the vertical support member.

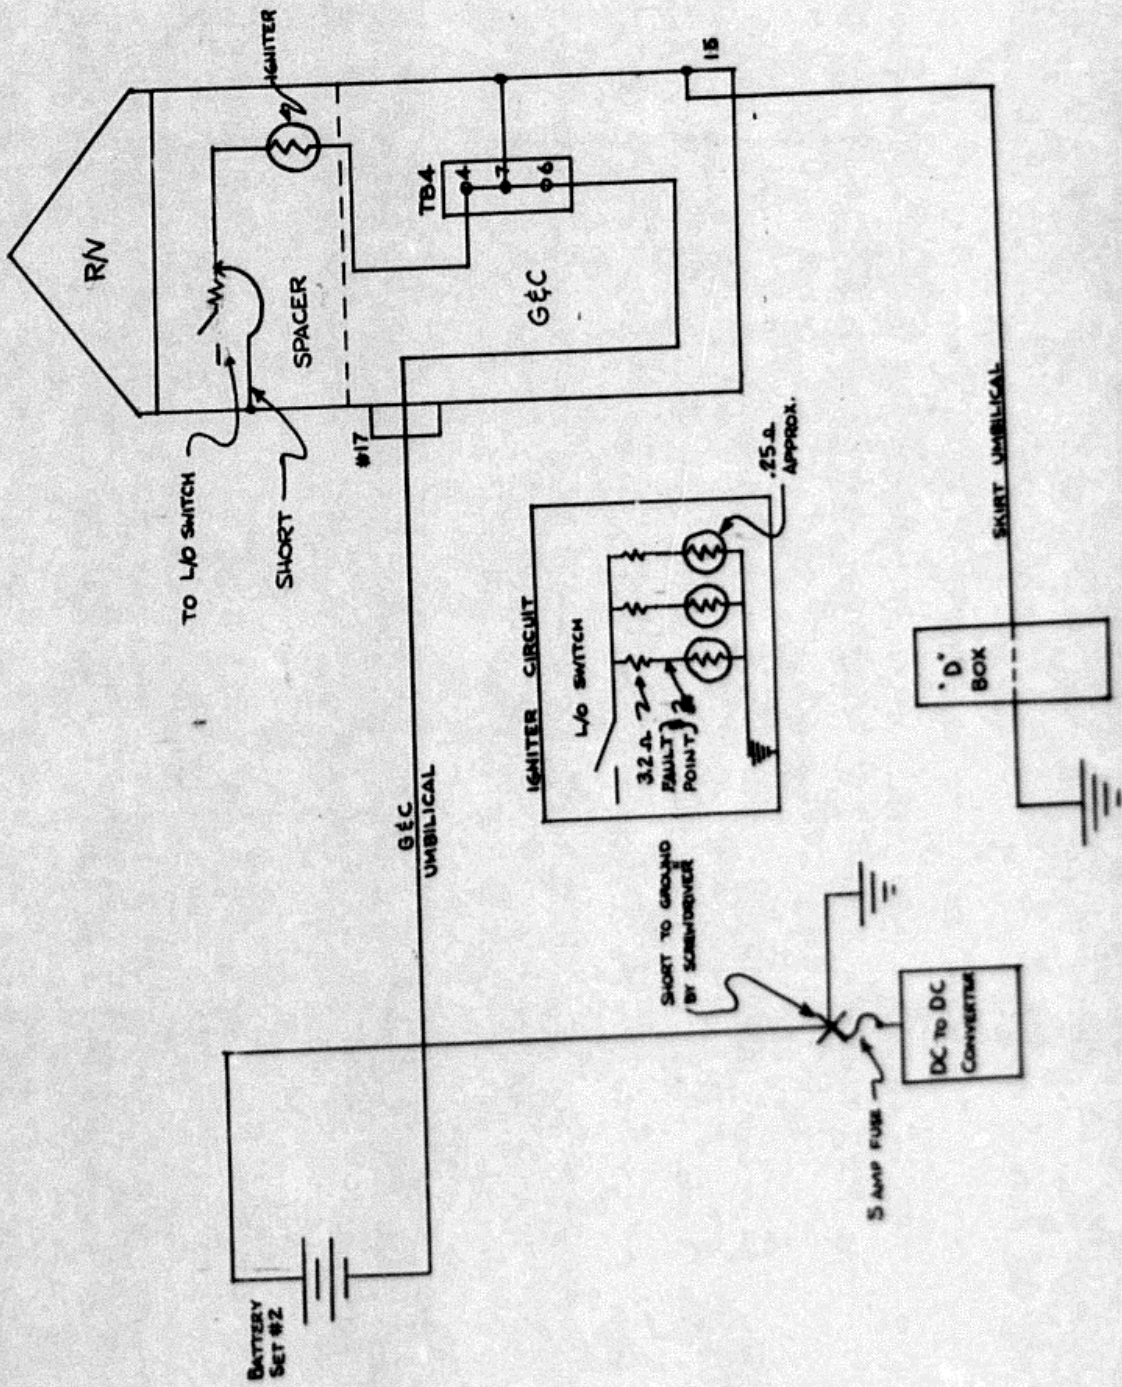
DIAGRAM OF FAULT CIRCUIT

PRIMARY CAUSE: Personnel Error, in that a maintenance technician inadvertently shorted a plus battery potential to ground. This application of plus battery voltage coupled with the fault in the retro cable connector provided a path for sufficient current to flow and ignite the retro rocket. The technician did not use the authorized, available tool to remove the fuse.

PAGE 2 RUWHHL 3D UNCLAS
PAGE 2-12, STEP 5 CONTINUED, REMEDY C-2. DISCONTINUE USE OF
PARAGRAPH C-2 OF STEP 5 IN FIGURE 2-7 OF T.O. 21M-LGM30A-2-19
IMMEDIATELY. FUSE F-1 FIGURE 4-4 ON PAGE 4-10 WILL NOT BE USED TO
CHECK OPERATION OF INNER SECURITY. DISCONNECTING PLUG P-1 ON
FIGURE 4-4, PAGE 4-10 COULD ALSO POSSIBLY RESULT IN A DANGEROUS
CONDITION AND SHOULD NOT BE ATTEMPTED. HAZARDOUS CURRENT CONDITIONS
MAY RESULT IF THESE CAUTIONS ARE IGNORED. THIS IS A COORDINATED
OOAMA, SAC, BSD/VWTMT/ MESSAGE. THE FORMAL ITOFCN WILL BE ISSUED
AS OF 7 DEC 64.
