Appendix 2

Minuteman IB Broken Arrow

The Accident

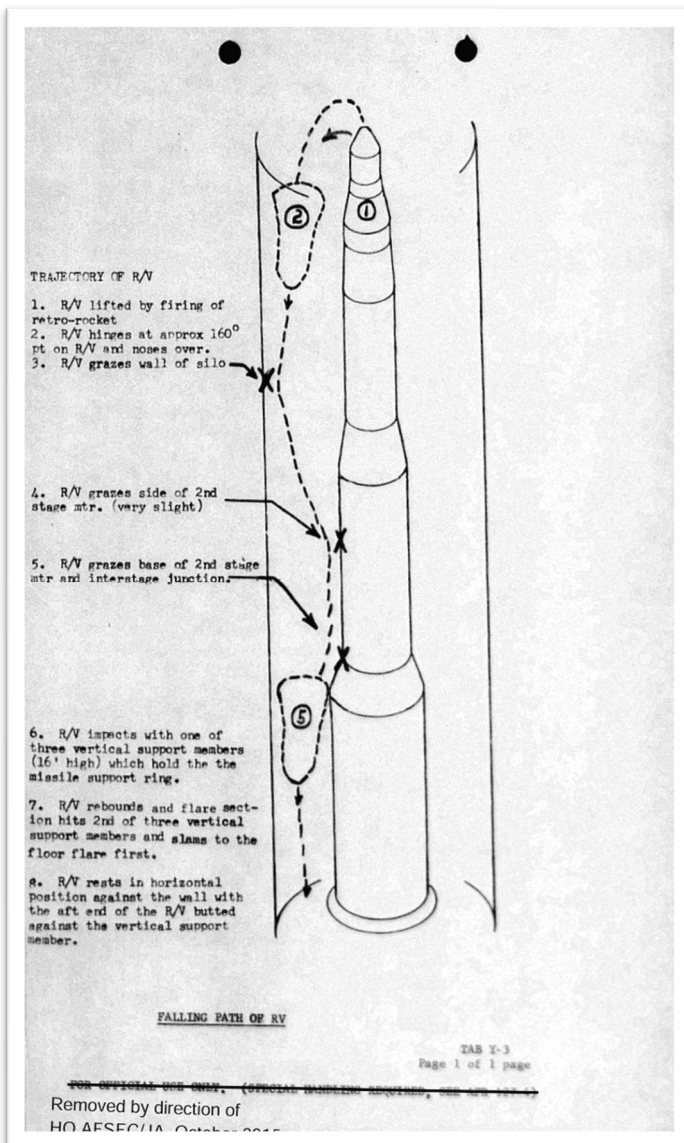
Figure 1. Assumed path of Mark 5 RV. USAF illustration

against the launch tube wall on the floor next to one of the suspension system spring cans (Figure 1). The only missing piece was the windshield, much to the relief of both men. The damage was sufficient to prevent the standard reentry vehicle handling equipment to be used for recovery. After they both had thoroughly examined the damage and ascertained it was safe to move it, the two men, with the EOD technician at the work cage controls to become familiar with them, began the ascent back up the launch tube. Upon reaching the work platform, the two climbed out of the cage, removed their safety belts and climbed back up the ladder of the access tube.
